# Manhole Inspection Summary

Manhole # S15Y\_\_005MH

Insp Date: **6/25/08 10:10 AM**

**Location** Address: **1400 desoto rd**

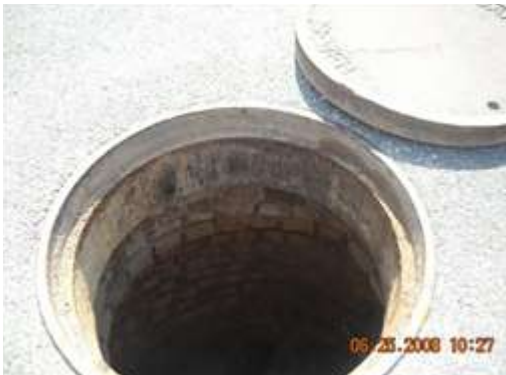
Misc

inflow evidence from sheeting

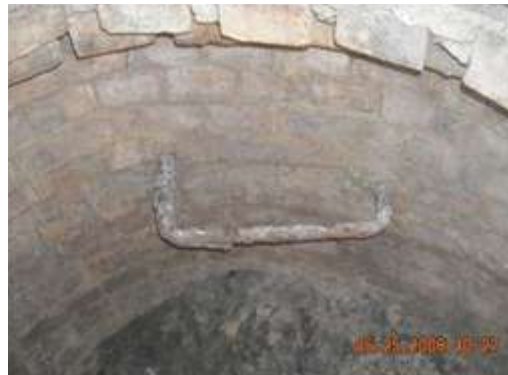
Defect 2

**Steps** Count: **1** Missing: **0** ☒ **Corroded**

corroded step

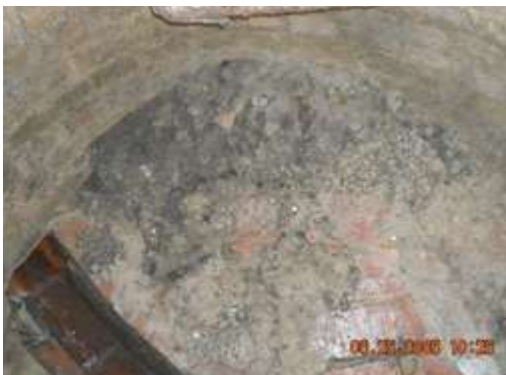
Defect 1

Condition: ☐ Sound ☐ Cracked ☐ Root Intrusion ☐ Deteriorated ☐ Leaks ☒ **Debris**

debris on bench

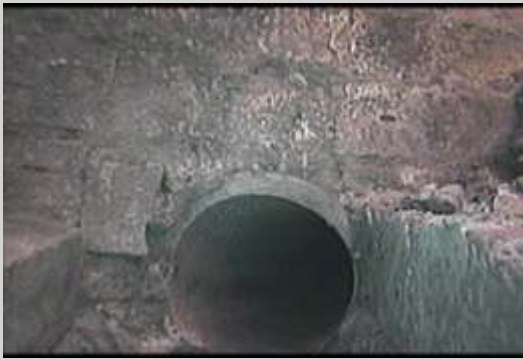
12 O'Clock Outflow

8 in. Circular Gravity Sewer  
Pipe Out @ 12 O'Clock

Pipe Height: **6** (in.) Rod and Bar (Angled)  
Pipe Material: **Clay** ☐ Pipe Lined  
Invert Depth: **6.00** (ft.) Flow Characteristics: **Slow**  
Deposits: ☒ None ☐ Mud ☐ Sludge ☐ Debris ☐ Grease  
Silt Depth: **0** (in.) Deposits Extent:  
Infiltration: **None** Pipe Seal Cond: **Sound**

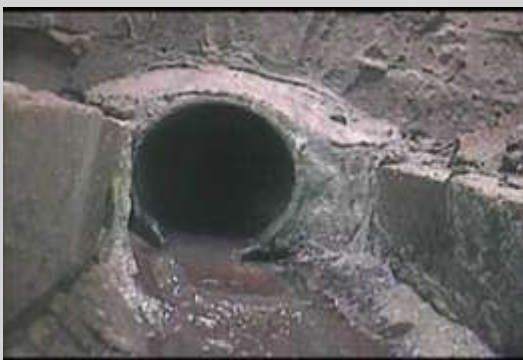
5 O'Clock Inflow

6 in. Circular Gravity Sewer  
Pipe In @ 5 O'Clock

Pipe Height: **6** (in.) Rod and Bar (Angled)  
Pipe Material: **Clay** ☐ Pipe Lined  
Invert Depth: **5.78** (ft.) Flow Characteristics: **Slow**  
Deposits: ☒ None ☐ Mud ☐ Sludge ☐ Debris ☐ Grease  
Silt Depth: **0** (in.) Deposits Extent:  
Infiltration: **None** Pipe Seal Cond: **Sound**
